United States Department of the Interior
National Park ServiceNational Register of Historic Places
Registration Form

historic name Johnson, Wilbur T. and Rhoda Stephens, House
other names/site number Missouri State DAR Headquarters
Roslyn Heights, 0-32

street & number 821 Main N/A not for publication
city, town Boonville N/A vicinity
state Missouri code MO county Cooper code 053 zip code 65233

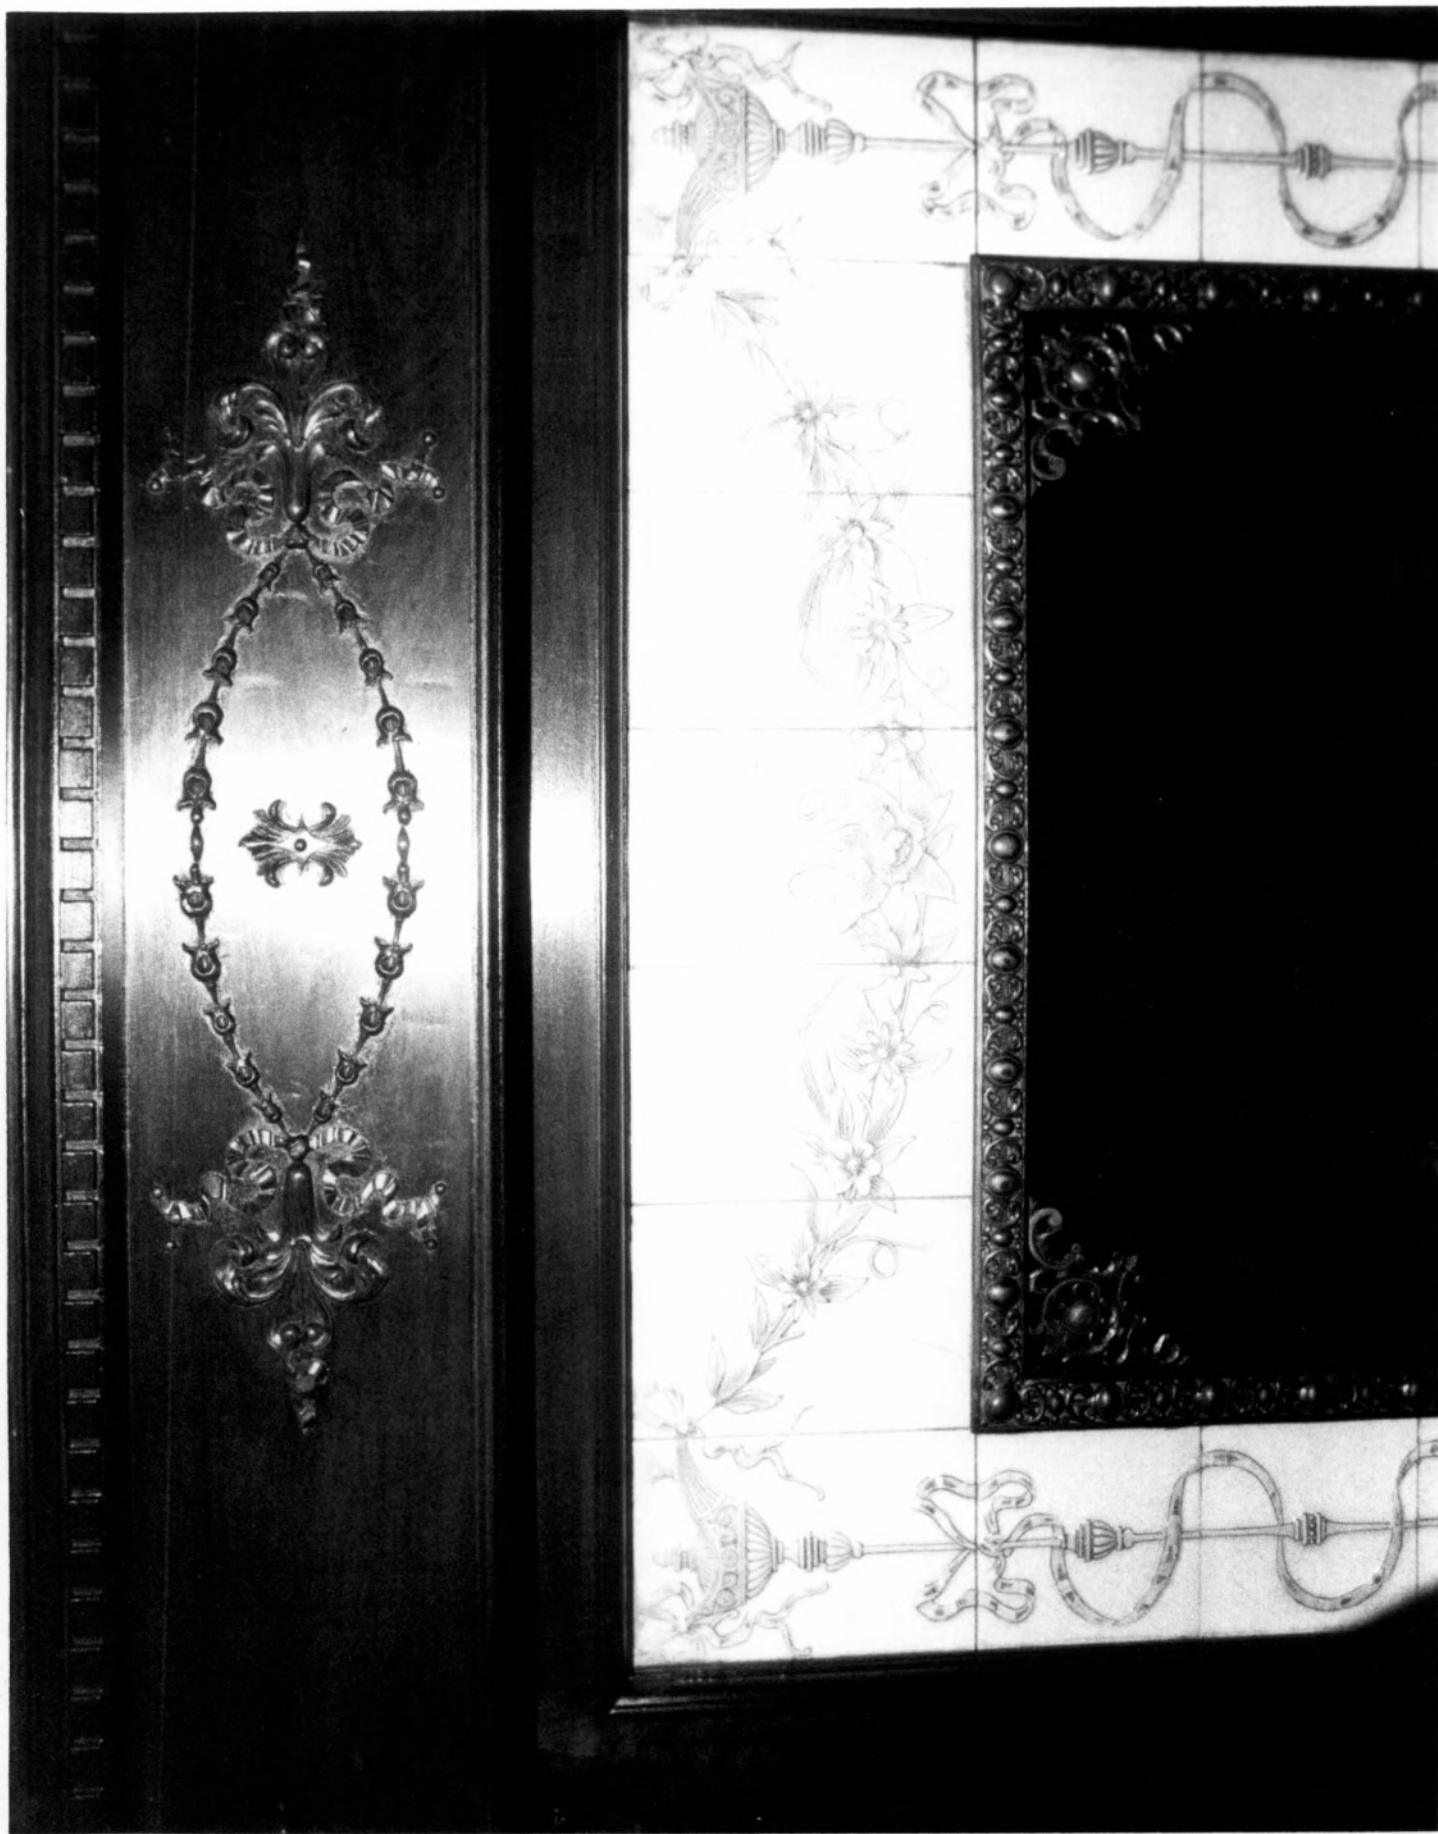
Roslyn Heights
Boonville, Missouri
Maryellen H. McVicker
January 10, 1987
DAR Headquarters at House
Detail--Parlor Fireplace
Photo #18

In the southeast parlor is a hand painted ceiling with a festoon of flowers, the only one of four frescos left in the house. The frescoes were painted by an unknown artist who lived with the Johnson family for three weeks when the house was first completed. The fireplace in the parlor is mahogany and has decorative embossed tile and a brass panel in a floral pattern behind the fire grate. The original dining room and library have polygonal bay windows. The library (now used for dining as well) has a fireplace mantel of mahogany with blue elaborately detailed embossed tile. The opening of this fireplace has a decorative brass molding, but not the embossed firebox panel. The original chandelier dating back to 1895 hangs in the room. The original dining room features spindle bent wood framing the polygonal windows and a plate rail. The fireplace has brown embossed tile in a fruit pattern and the mantel is oak with ornate carving and glass shelves for display areas. The chandelier in this room is also original.

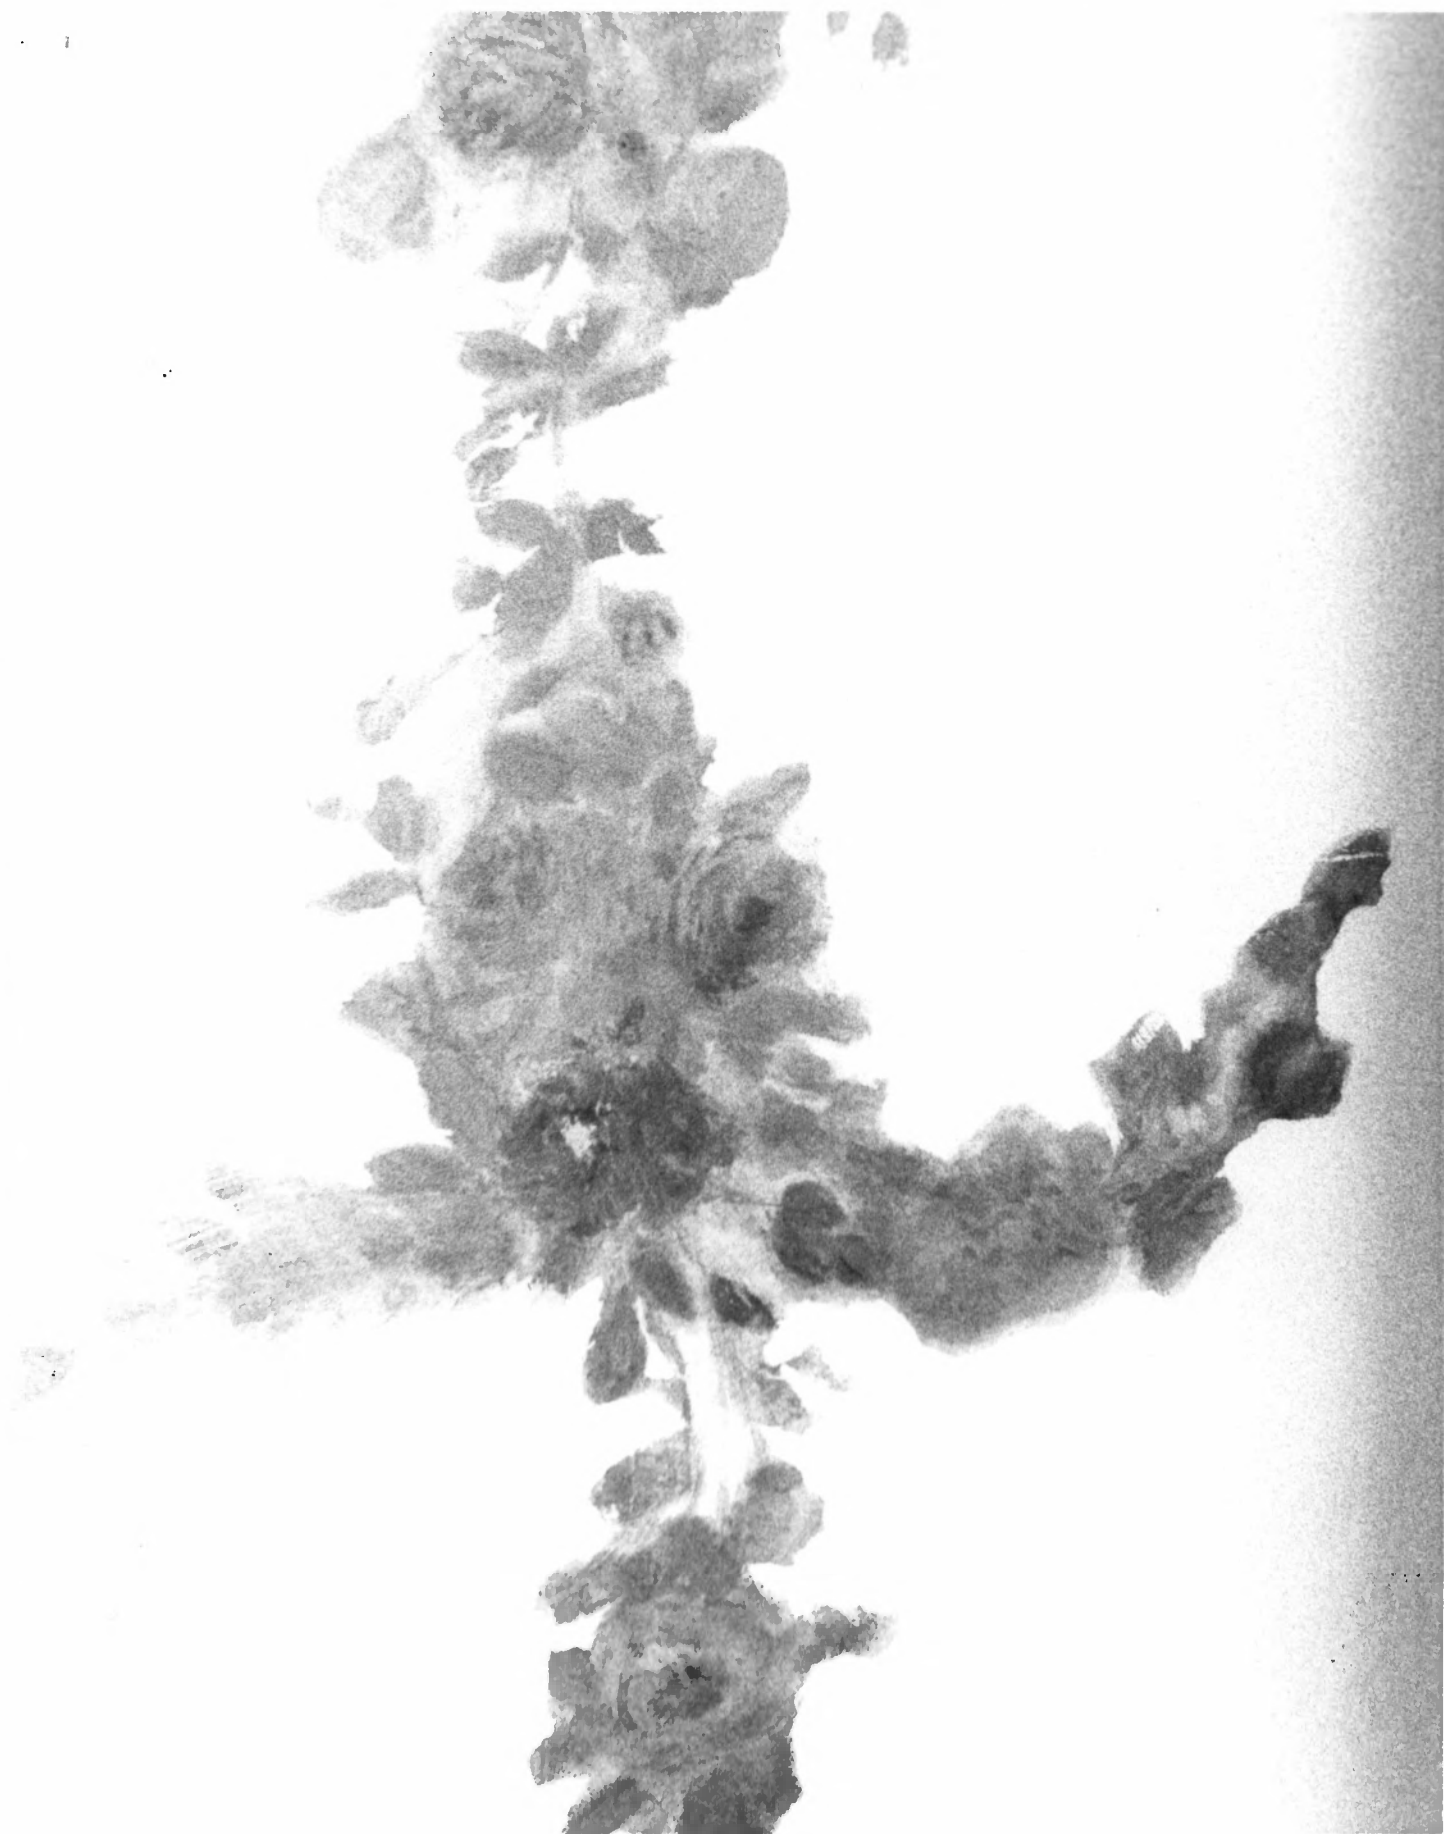
Roslyn Heights
Boonville, Missouri
Maryellen H. McVicker
January 10, 1987
DAR Headquarters at House
Detail--Parlor Fresco
Photo #19

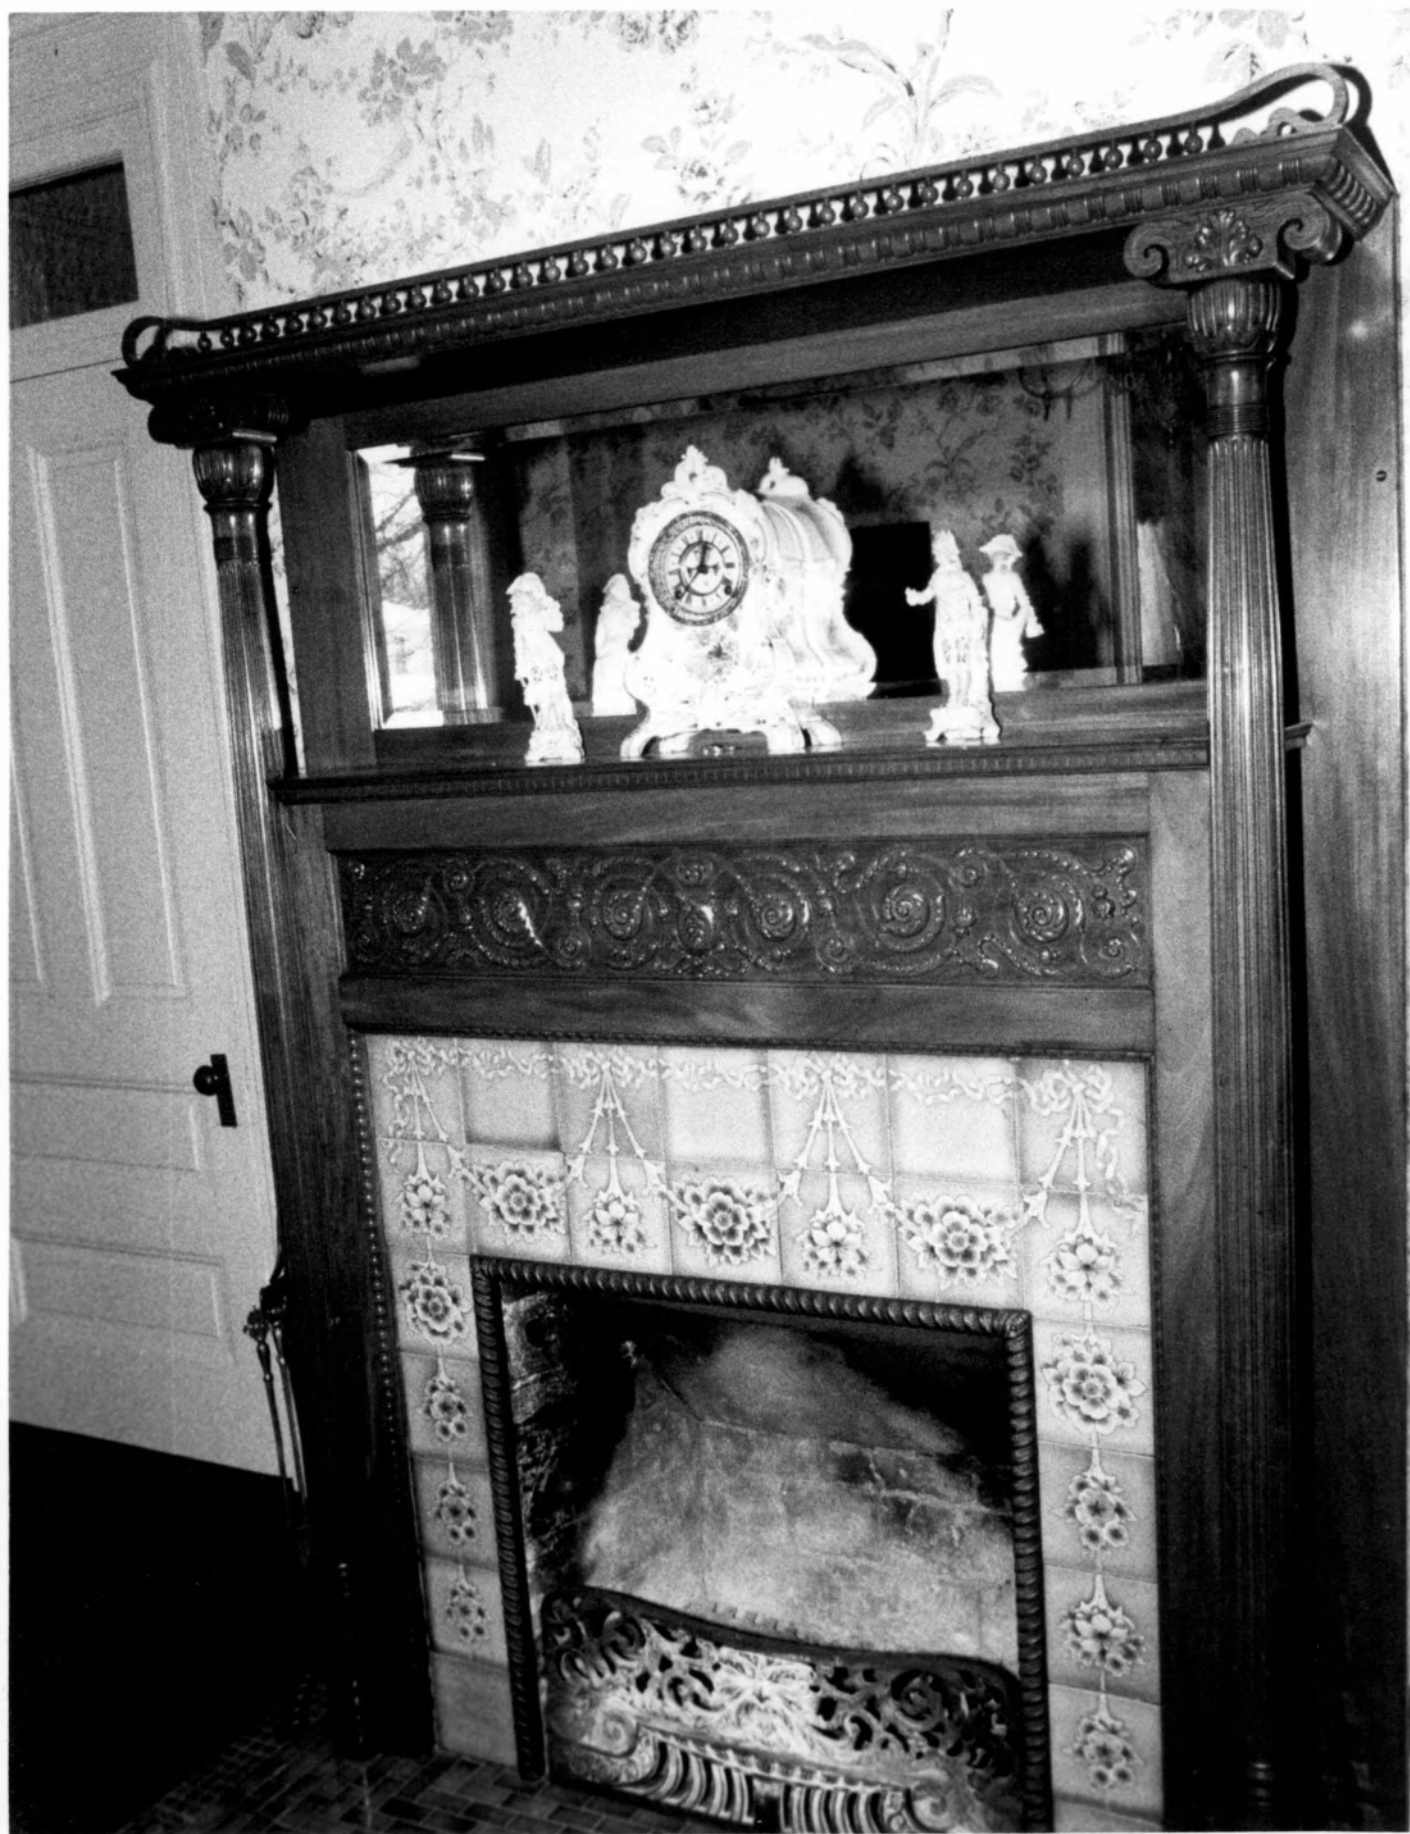
Roslyn Heights
Boonville, Missouri
Maryellen H. McVicker
January 10, 1987
DAR Headquarters at House
Library Fireplace
Photo #20

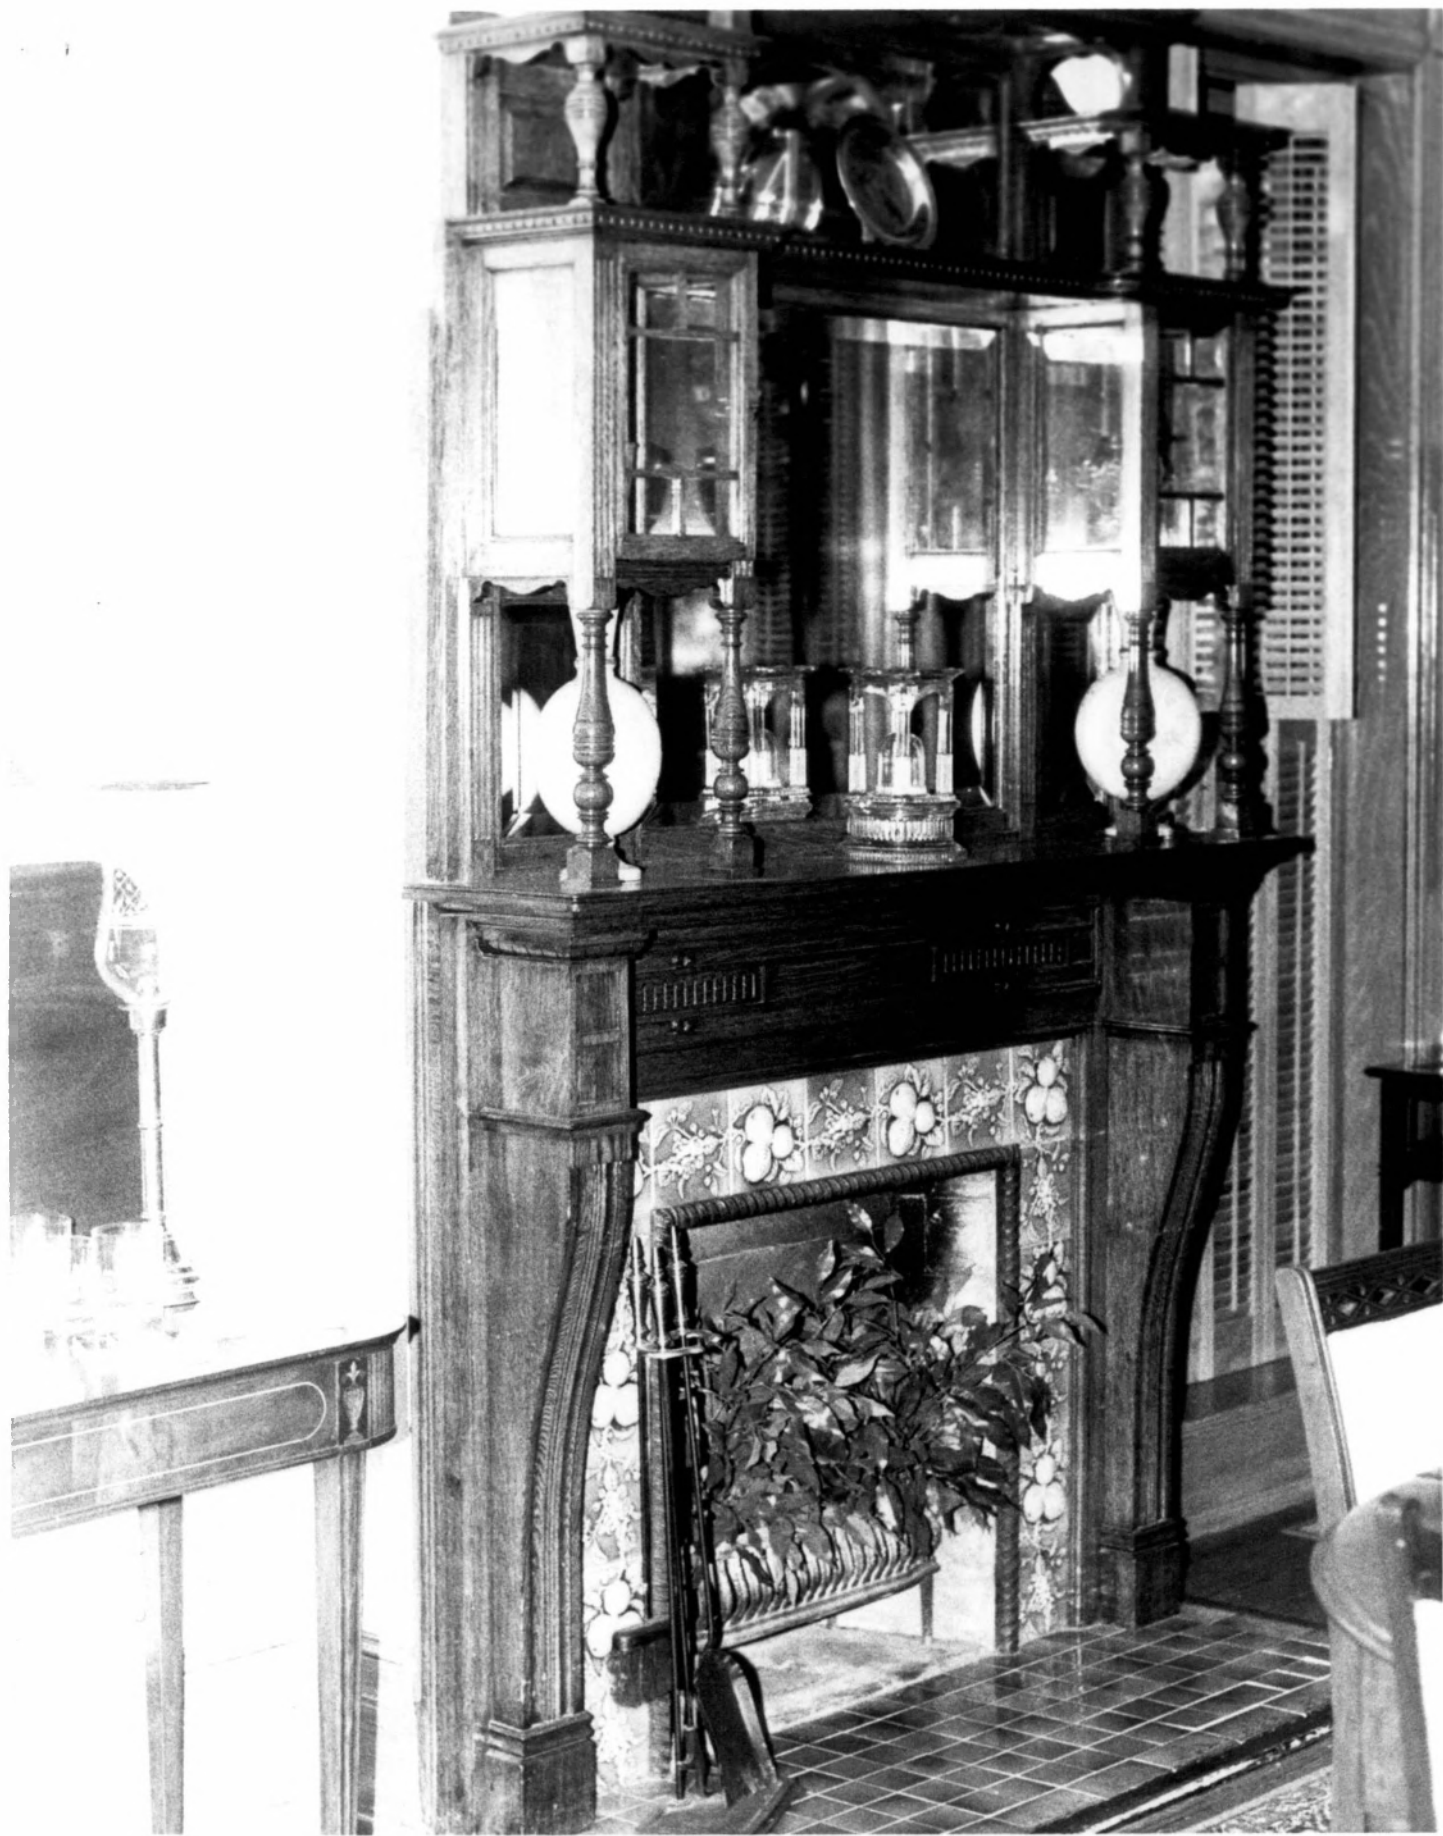
Photo #22

Roslyn Heights
Boonville, Missouri
Maryellen H. McVicker
January 10, 1987
DAR Headquarters at House
Dining Room Fireplace

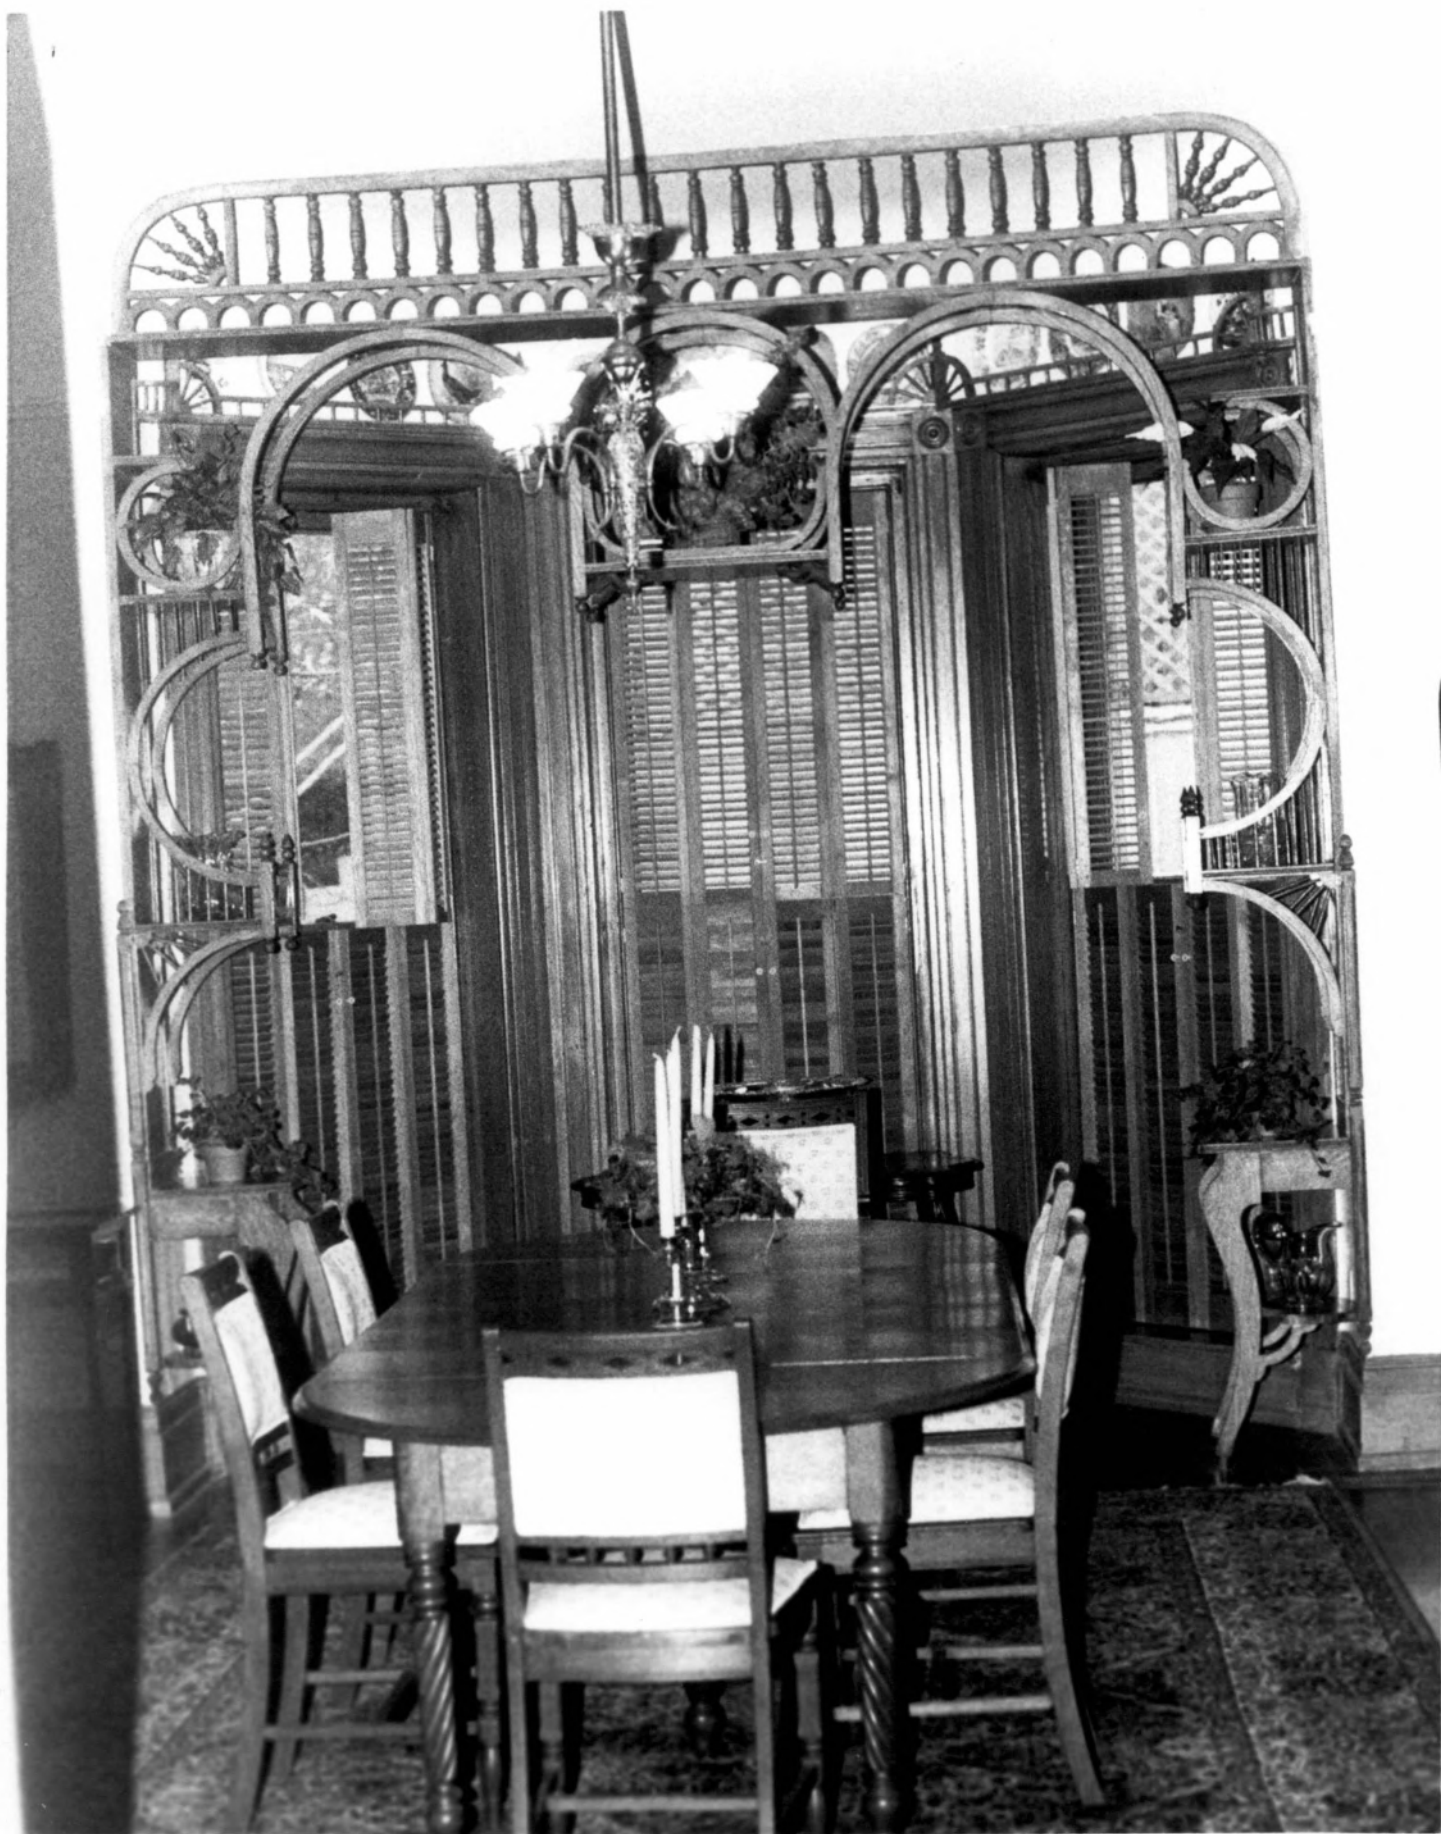
Roslyn Heights
Boonville, Missouri
Maryellen H. McVicker
January 10, 1987
DAR Headquarters at House
Dining Room Canopy
Photo #23

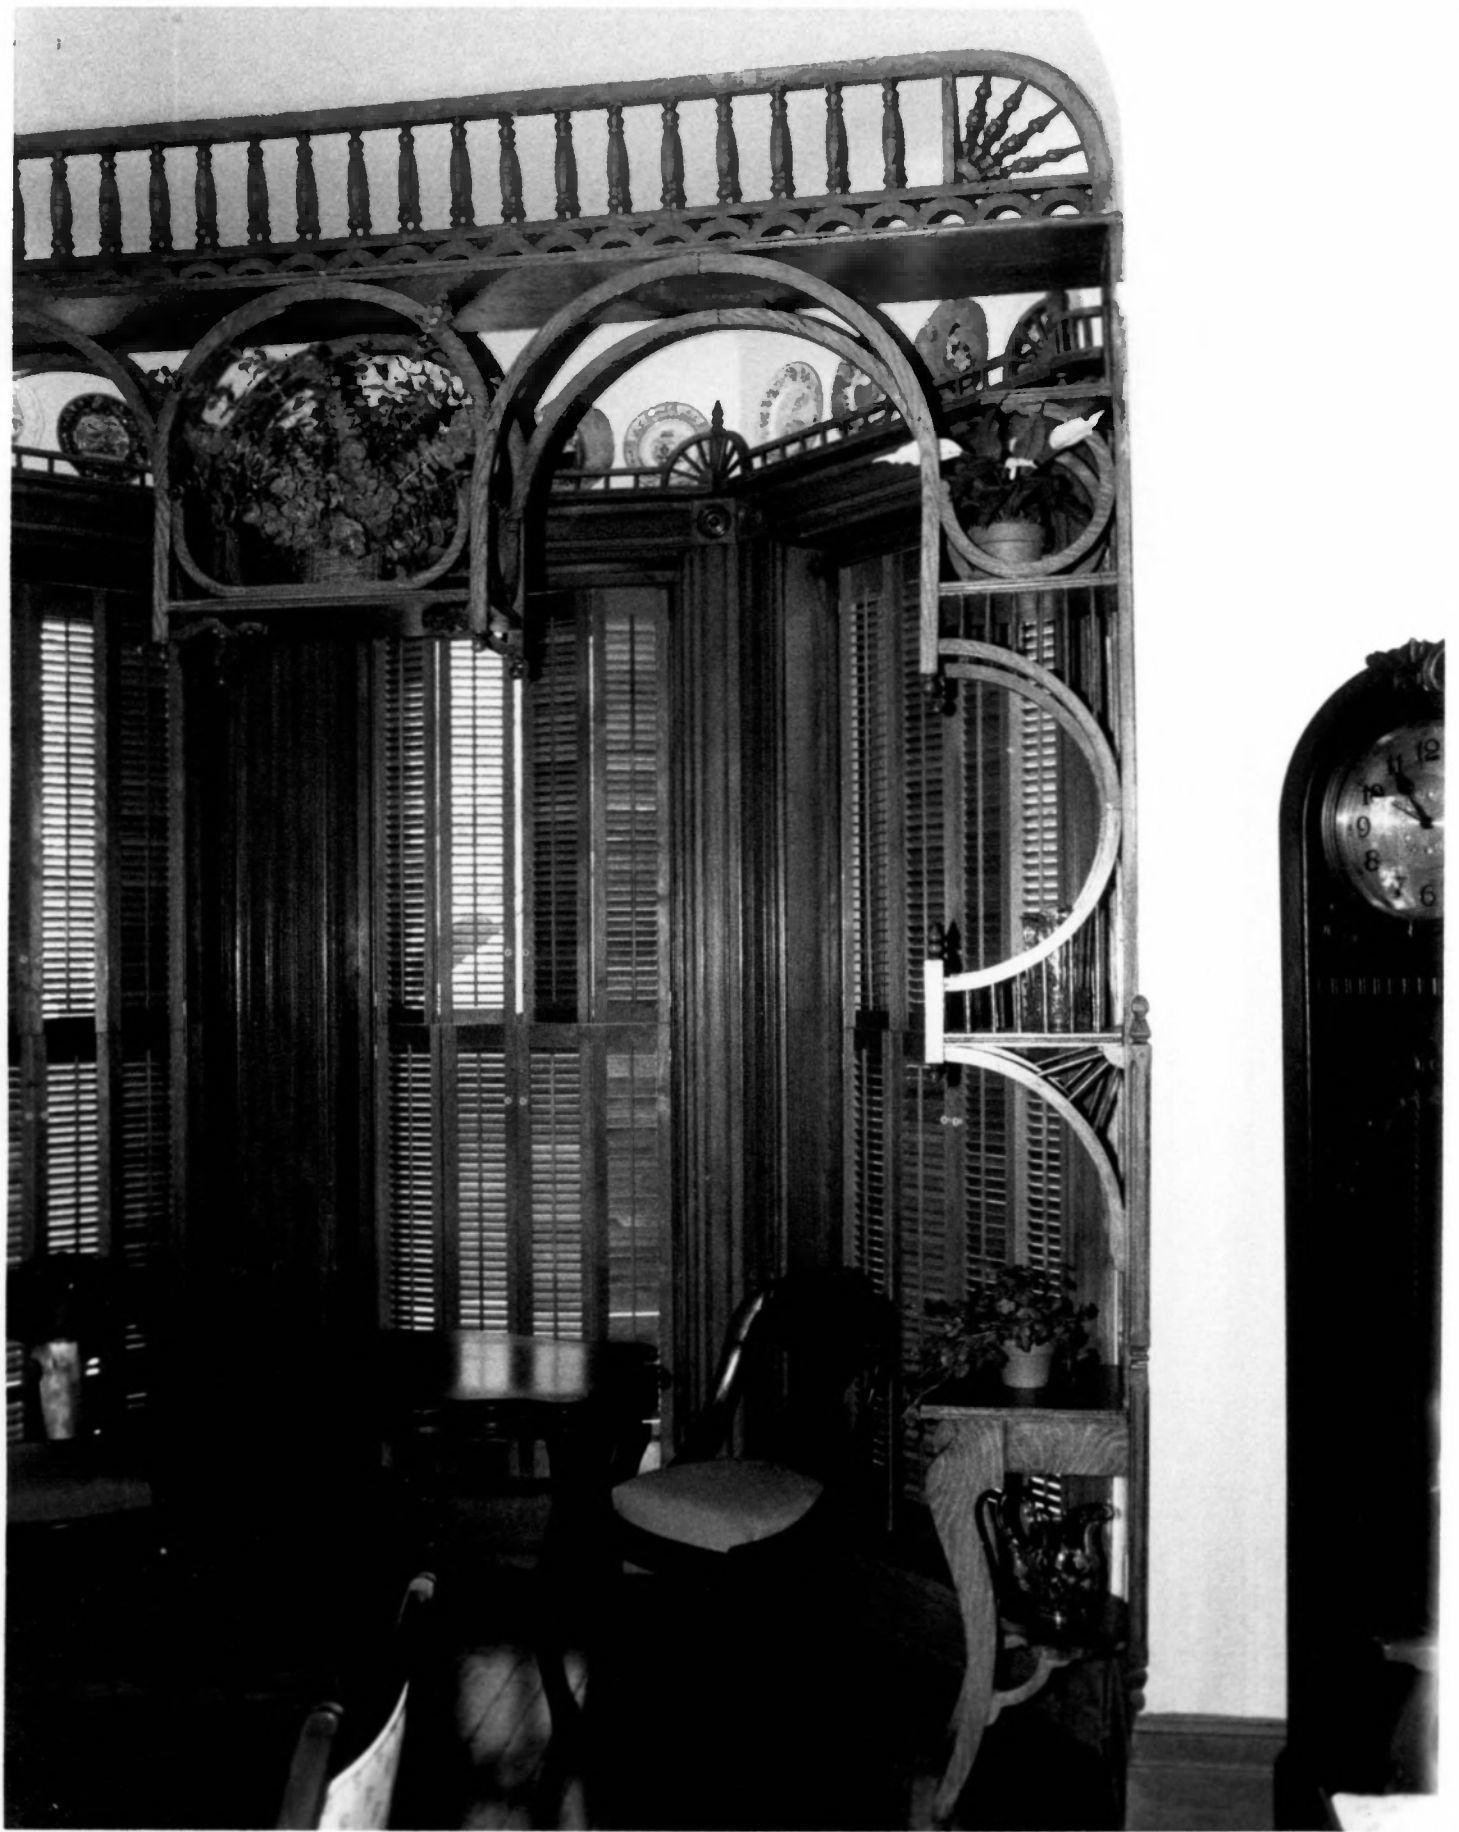
Roslyn Heights
Boonville, Missouri
Maryellen H. McVicker
January 10, 1987
DAR Headquarters at House
Section of Dining Room Canopy
Photo #24

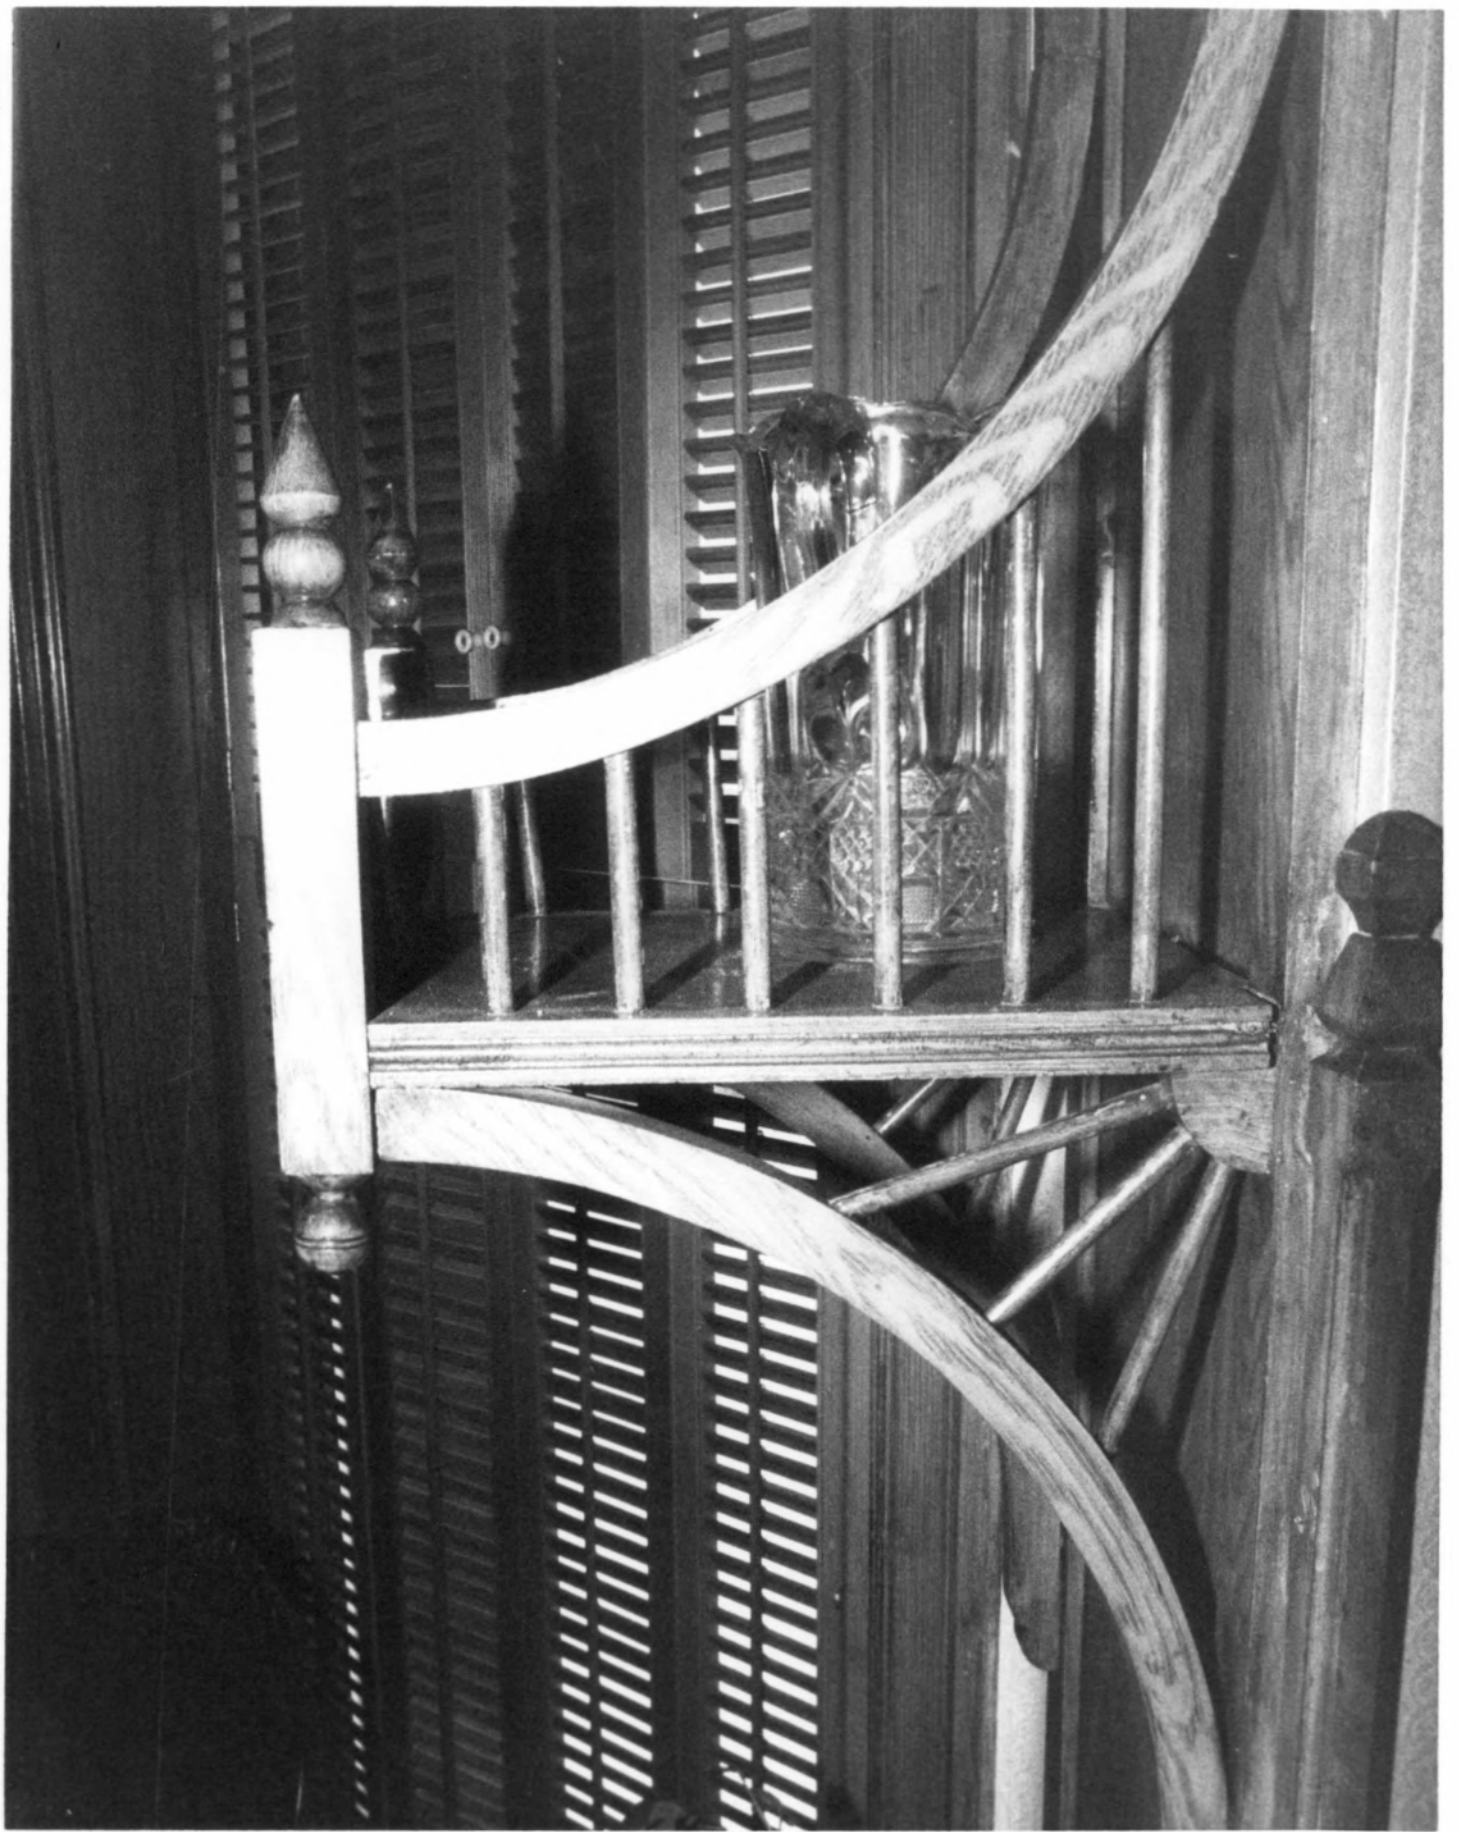
Photo #25

Roslyn Heights
Boonville, Missouri
Maryellen H. McVicker
January 10, 1987
DAR Headquarters at House
Detail--Dining Room Canopy

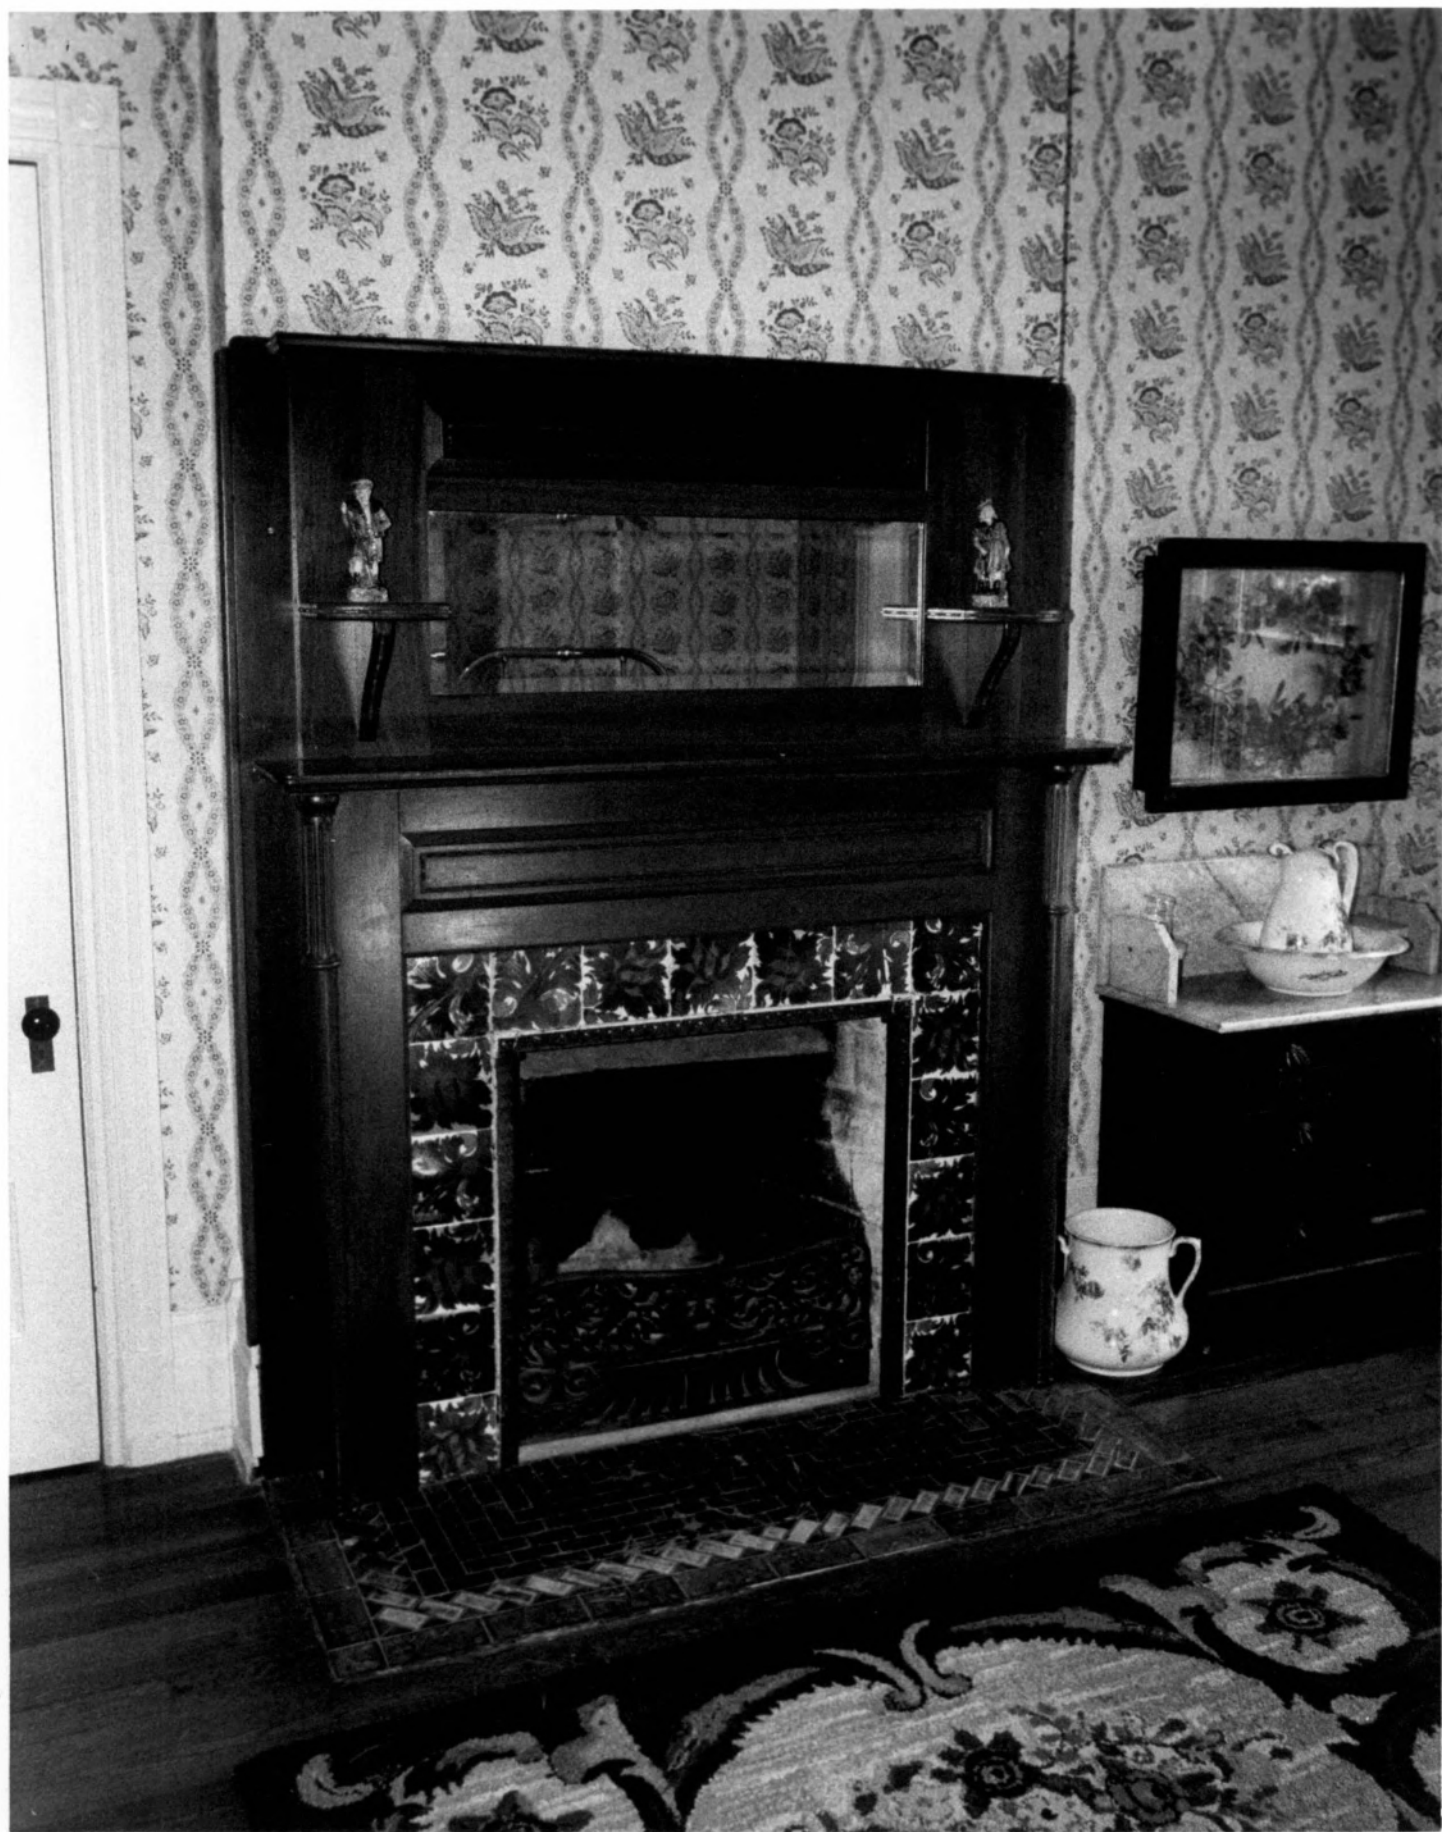
Photo #26

Roslyn Heights
Boonville, Missouri
Maryellen H. McVicker
January 10, 1987
DAR Headquarters at House
Upstairs Fireplace
